Deer Creek Bank Erosion Monitoring Past, Present, and Future

Litzsinger Road Ecology Center
Missouri Botanical Garden

A project for completion of degree
MS Environmental Studies
Antioch University New England
Maisie Tyler Rinne
2013

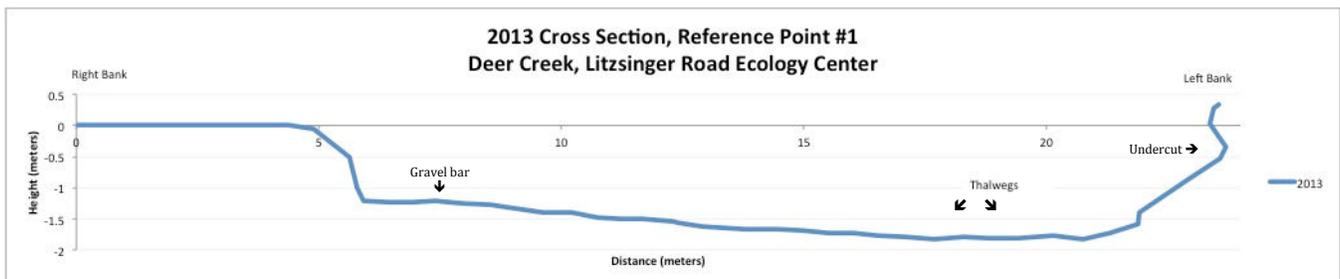
Figure 3

The right bank, which marks the location for Reference Point #1, is much lower than the opposite bank at this point in Deer Creek. The right bank has easy access to its floodplain, has a moderate slope and fairly good coverage by plants. According to the Bank Erosion Potential Rating (BEPR) index, the right bank scored a 5.75 which indicates the bank is only at moderate risk for bank erosion. The bank's composition of mostly small materials (fine gravel, silt, and clay), make it the most susceptible to erosion.

The left bank at Reference Point #1 is much higher than the right bank and is terraced in several places. For this study, we determined the Top of Bank at a rather large terrace (about 2 meters wide) just less than a half meter taller than the right bank. However, the left bank continues to climb uphill another approximately 4 meters to the level of the rail trail. The difference in bank elevations has caused incision in the left bank as bankfull elevations cut into the left bank while draining into the floodplain on the right bank. Note the undercut evident in Figure 3. The Bank Erosion Potential Rating for the left bank is a 3.25, indicating it is at a high risk.

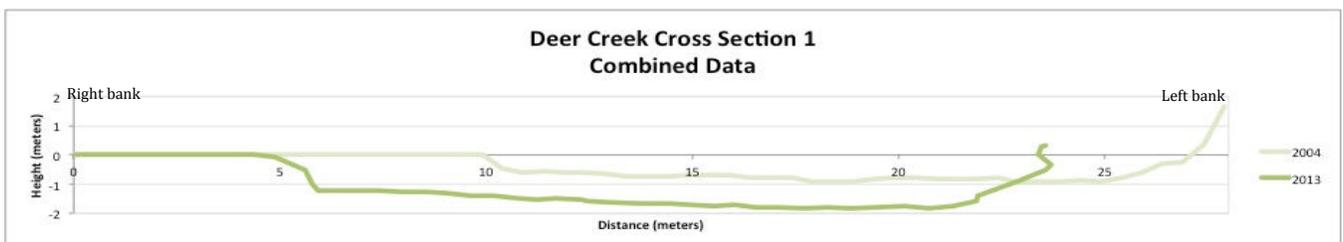
Figure 4

The Top of Bank for Cross Section #1 was located 4.35 meters from the permanent post at a 90° bearing. In the 2004 study, the Top of Bank was determined to be 9.9 meters from the reference point at the same angle. The difference in distance is most likely a combination of bank erosion and angle error. As evidenced in the comparison graph of the 2004 and 2013 studies (Figure 4), a little error in angle across a great distance can lead to dramatic differences.

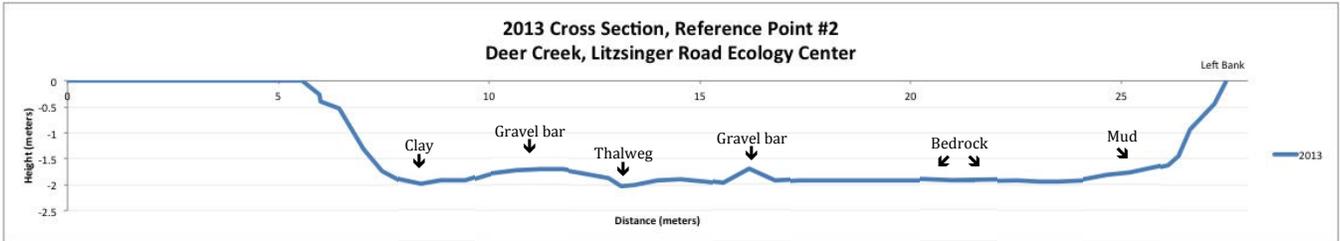
Figure 5

The right and left banks at Reference Point #2 are rather even in height, angle, and composition with an overall Bank Erosion Potential Rating of 4.25 for the right bank and 4 for the left bank indicating both banks at a moderate to high risk for bank erosion. The main difference in these banks is how they are maintained. The right bank, being consistently maintained, is flush with native grasses, while the left bank, rarely maintained, is overgrown with bush honeysuckle. Both banks are composed mostly of clay and mud, though the right side of the channel hosts a gravel bar, whilst the majority of the streambed consists of mostly bedrock.

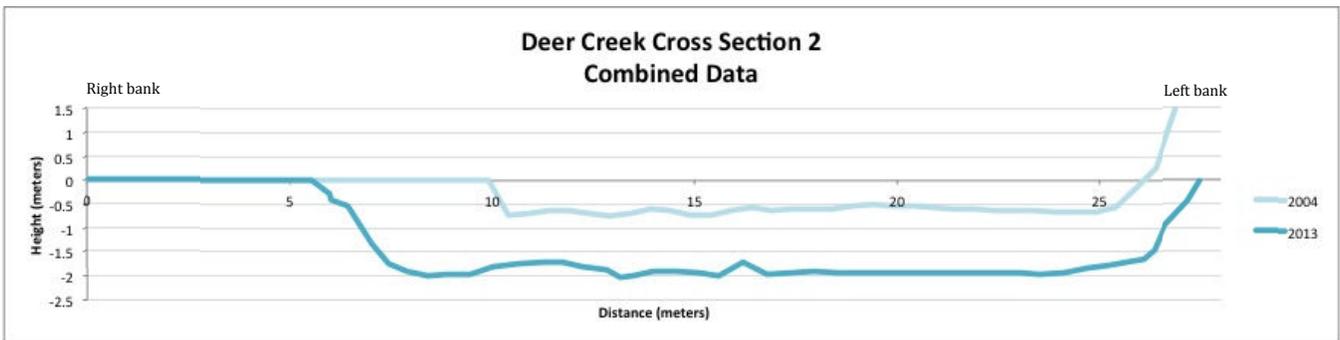
Figure 6

The Top of Bank for Cross Section #2 was located 5.55 meters from the reference point at a 90° bearing. In the 2004 study, the Top of Bank was determined to be 9.9 meters from the reference point at the same bearing. The difference in distance could be a combination of eroded bank and angle error. In 2004, the left bank was found to be much higher than the right bank. A leveling of the two banks to near equal could possibly be another discrepancy in bank angle or methods.

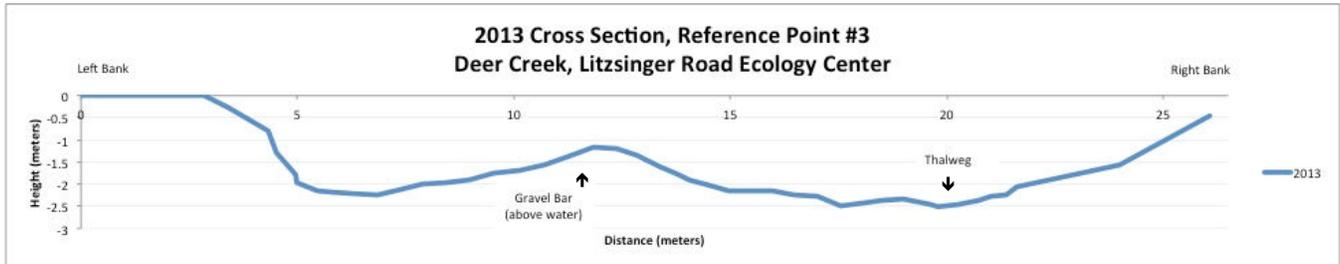
Figure 7

Reference point #3 is the only reference point located on the left bank. At this particular location the left bank is far more stable than the right bank, thus the location of the reference point. Both left and right bank are fairly even in height, though the left bank is far more vegetated than the right bank and a bit steeper in slope. Near the center of the streambed is a large gravel bar that divides the waterway. The streambed depth on the left side of gravel bar has gotten noticeably deeper since 2004. Due mostly to poor composition, both banks are rated high on the Bank Erosion Potential index, the left bank scoring a 3, and the right bank, a 4.

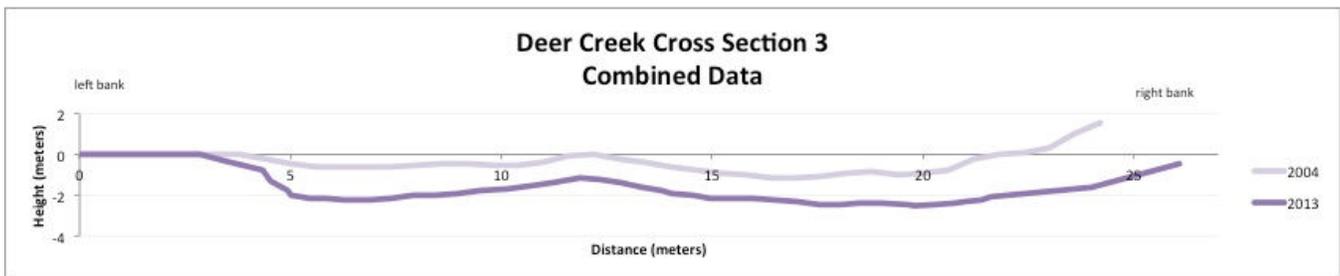
Figure 8

The Top of Bank was found to be 2.84 meters from the reference point on the left bank at a declination of 170°. In 2004, the Top of Bank was determined to be 3.8 meters from the reference point at the same declination. However, due to the recent live-fall of a huge cottonwood on the right bank, the declination across the streambed was changed from 186° in 2004, to 170° in 2013 in order to properly access the right bank. Because of the intended change in angle, the two cross sections from 2004 and 2013 shouldn't be compared too closely, although they have been illustrated in figure 8 side by side.

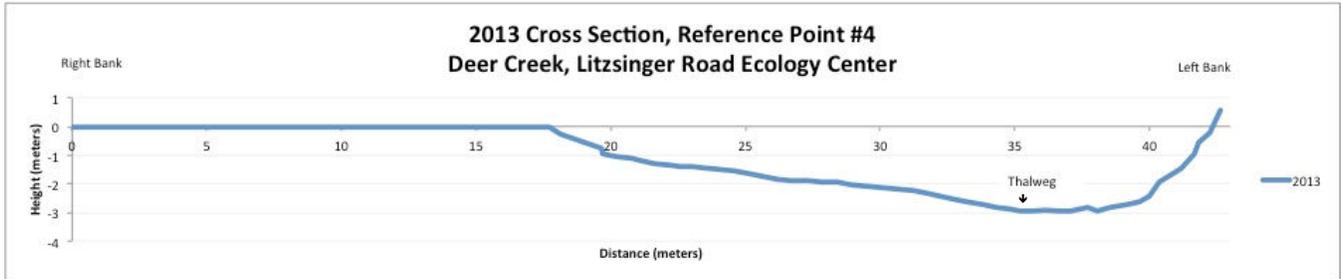
Figure 9

The right and left banks at Reference Point #4 are fairly even in height, though vary greatly in slope, composition, and access to floodplain. The right bank at this juncture scored a medium-low Bank Erosion Potential Rating of 7.5, while the left bank scored an extremely high Bank Erosion Potential Rating of 2.25. The high potential of the left bank for erosion is mostly due to its composition (non-vegetated mud) and its steep slope. Unlike many of the other sites, this site lacks the presence of any bedrock or boulders and is mainly composed of gravel, cobble, mud, and sand.

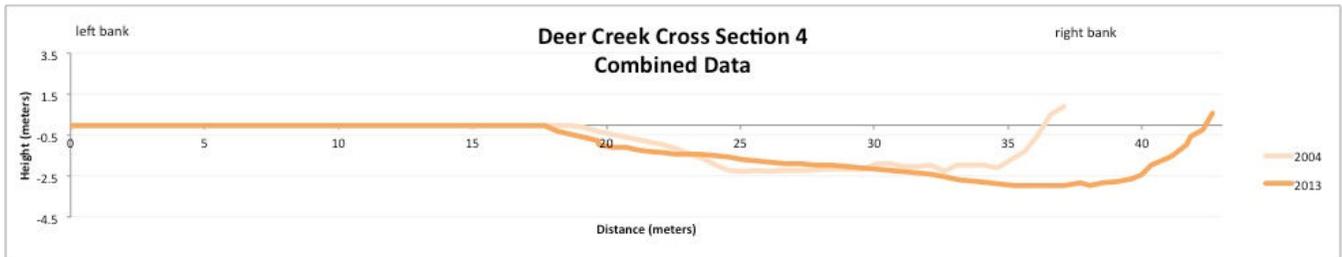
Figure 10

The Top of Bank at Reference Point #4 was found to be 17.7 meters from the permanent marker at a 130° declination. In 2004, the Top of Bank was determined to be 18.6 meters from the reference point at the same declination. With such a distance, we are certain there is much room for angle error, which could explain some of the discrepancies in the comparison graphs.

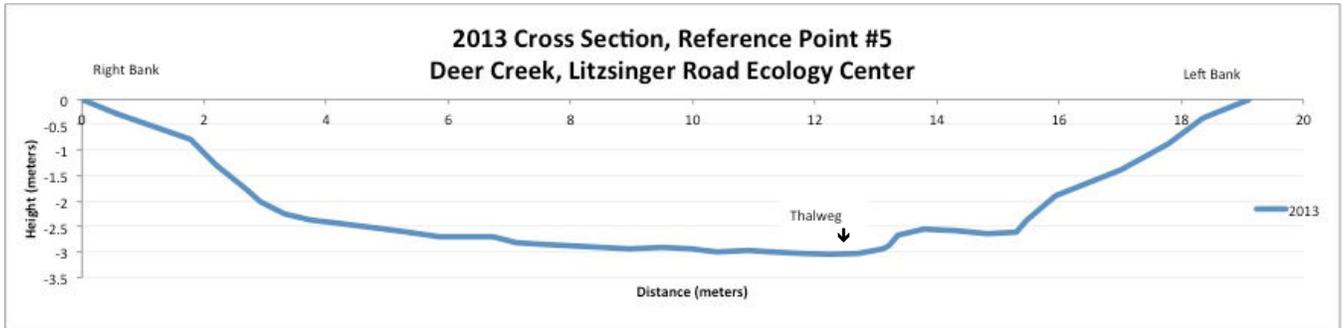
Figure 11

The banks of Cross Section #5 were relatively similar in height, composition, and slope. The section scored a combined Bank Erosion Potential Rating of 5.25 on a spectrum of 1-10 indicating the site has only a moderate potential for bank erosion. Both banks were vegetated lightly with gravel present toward the bottom of their banks.

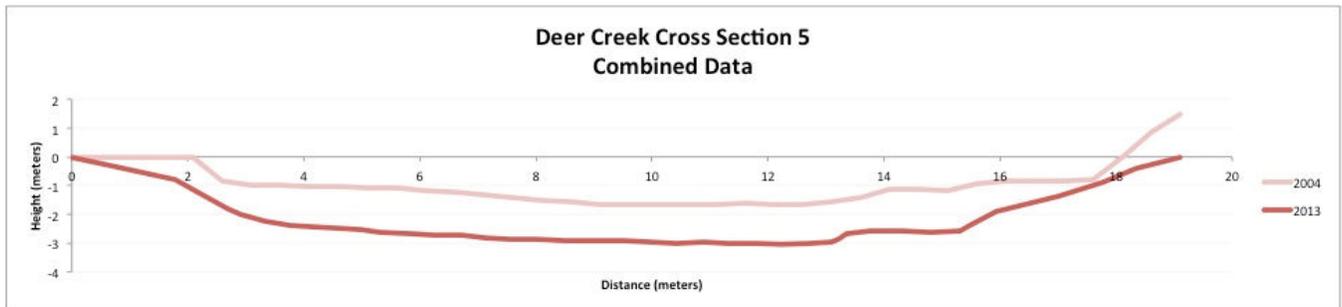
Figure 12

The Top of Bank was determined to be at the same point as the permanent marker reference point. However, in 2004, the Top of Bank was found 2.1 meters from the reference point at a bearing of 38°. Based on observations by employees and volunteers, this bank has, indeed, eroded quite a bit in the past few years and it is possible that the Combined Data graph is fairly accurate. A bearing of 38° was used to find the location of opposite bank for both studies.

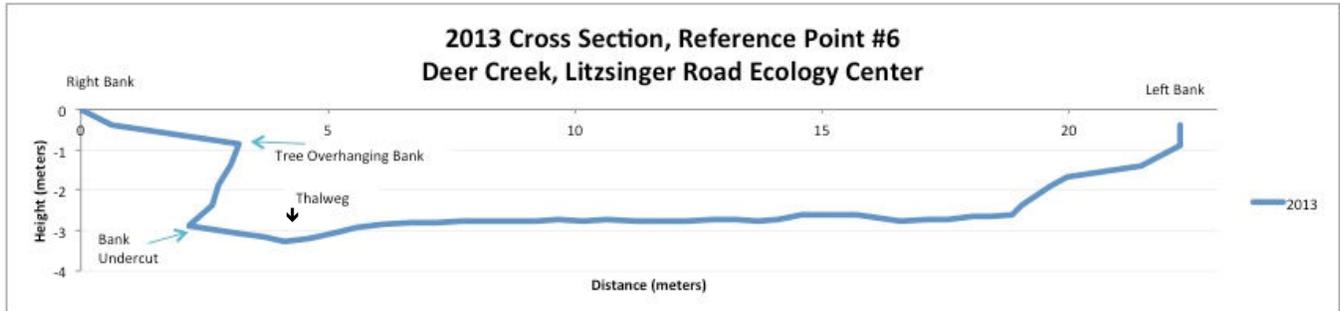
Figure 13

The right and left banks at Cross Section #6 are quite different from one another. Most noticeably, there are two Hackberry trees jutting out from the right bank which is causing a bulge in the bank. Additionally, some stream mitigation has been performed upstream causing the stream flow to widen. However, the main flow of the creek at this point still undermines the right bank, as it was tending to do in 2004 as well. The left bank is slightly sloped, terraced, and well vegetated. In the center of the streambed is a wide gravel bar.

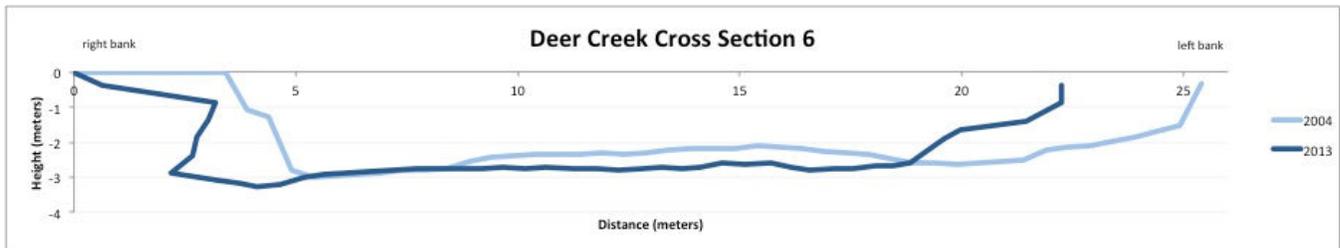
Figure 14

The Top of Bank was found to be at the same point as the reference stake in 2013. However, in 2004, the Top of Bank was determined to be 3.4 meters from the reference stake at a bearing of 44° . After data was collected for this site, we determined that the 3.4 meter distance at the 44° declination was created to avoid the overhanging Hackberry tree which would give a more accurate bank reading. Both studies used a declination of 75° to determine the opposite bank point.
