## Executive Summary

This report presents the findings of the geomorphic field reconnaissance and preliminary management recommendations for a reach of Deer Creek, flowing through the Litzsinger Road Ecology Center property in the City of Ladue, Missouri. The study reach includes approximately 2,500 linear feet of stream channel. The data gathering and analytical methods applied during this study are generally consistent with those of US Army Corps of Engineers (USACE) Engineering Manual 1110-2-4000 and the Federal Emergency Management Agency's (FEMA) 1999 report to Congress, *Riverine Erosion Hazard Area Mapping Feasibility Study*.

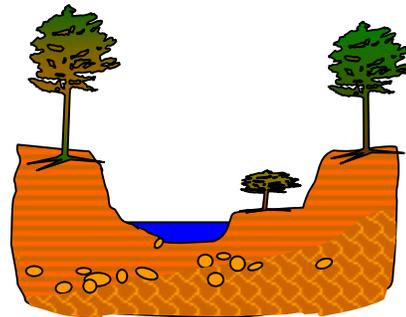
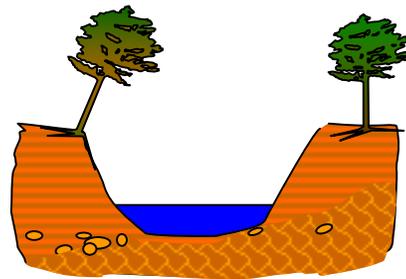
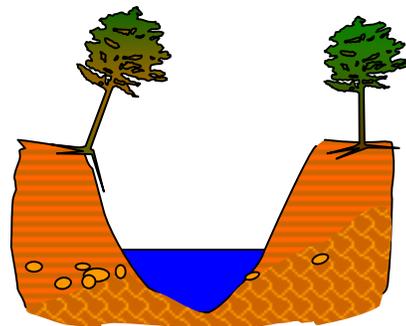
Figure 1: Channel Evolution Model (from Simon, 2001).

**Stage I Pre-disturbance**

- Bed and bank materials balanced with erosive forces
- Permanent woody vegetation near the water line
- Two-stage channel shape evident at about 1.8 year return interval

**Stage II Disturbance**

- Channel altered, hydrology or sediment inputs modified
- Removal of permanent woody vegetation near the water line
- Two-stage channel shape eliminated or no longer supported by flow conditions

**Stage III Incision**

- Downcutting liberates sediment
- Lost or perched bankfull floodplains
- "U" shaped channel
- Woody vegetation high on bank

Simon (2001) separates changes in channel morphology into six stages: I) Pre-disturbance, II) Disturbance, III) Incision, IV) Widening, V) Deposition, and VI) Recovery and Reconstruction.

At Stage I, the channel is stable and transports the water and sediment delivered to it without significant adjustment. Although not a universal feature, internal floodplains are common in stable streams including those in the Central Midwest. Bankfull floodplains occur at the elevation corresponding to the dominant discharge. The dominant discharge is the flow that, over time, accomplishes the most work on the stream channel. In undisturbed streams, the dominant discharge typically occurs every 1.5 to 2 years. The bankfull floodplain performs a valuable function by lowering the bank shear during higher flows and effectively managing the stream energy.

During Stage II, natural or manmade events disturb the channel. In disturbed systems, the dominant discharge often occurs far more frequently and may not support the development of internal floodplains. Common forms of manipulation include increases in the rate, volume or timing of flow or direct alteration of channel dimensions or alignment.

In Stage III, the stream cuts downward, lowering its channel slope to redistribute energy. This incision process migrates upstream. The migrating face of an incision front is referred to as a knickpoint or knickzone. The typical shape of these channels is V-shaped or narrow U-shaped. Incision proceeds until the channel has reached a stable slope, the incision reaches a more resistant layer or the stream banks begin failing because of mass wasting.

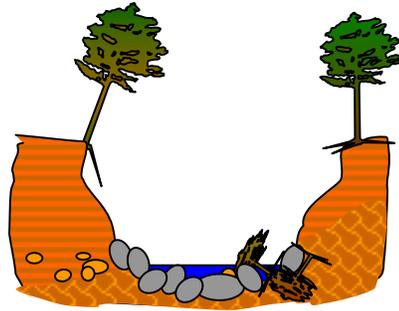
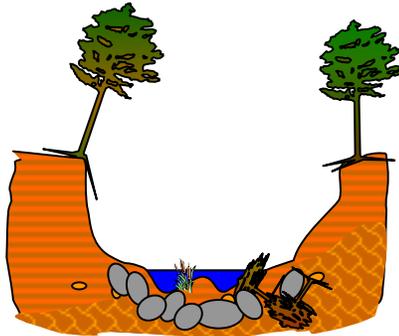
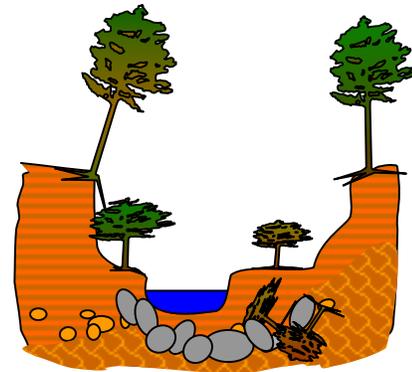
Figure 1: Channel Evolution Model (cont.).

**Stage IV Channel Widening**

- Widespread bank failures as banks exceed critical height or were undercut by toe scour
- Channel adjusts to new flow regime
- Significant sediment loads generated; most significant erosion hazard in this phase
- Bank armoring generally ineffective

**Stage V Deposition**

- Deposition begins from liberated sediment
- Vegetation establishes near water line

**Stage VI Recovery and Reconstruction**

- Bankfull floodplains may be reconstructed from liberated sediment
- Woody vegetation establishes near water line
- Stability re-established

Channel widening through mass wasting of the stream banks, Stage IV, follows incision. There are two common mechanisms of bank failure. Fluvial action erodes soil away from the toe of the slope resulting in a cantilevered bank, which eventually fails through toppling. Alternatively, the incision cuts deeply enough into the bed that the stream banks exceed their critical height and fail. Both mechanisms may operate in a stream.

The next phase of channel evolution is Stage V when the channel has sufficiently widened and begun depositing sediment eroded from upstream reaches in the bed. The deposits occur as channel bars and occasionally as internal floodplains. In Stage VI, the channel regains the equilibrium condition and efficiently transports both water and sediment. If a substantial increase in  $Q_w$  precipitated the adjustment, final dimensions of the channel will probably be larger than the pre-disturbance condition.

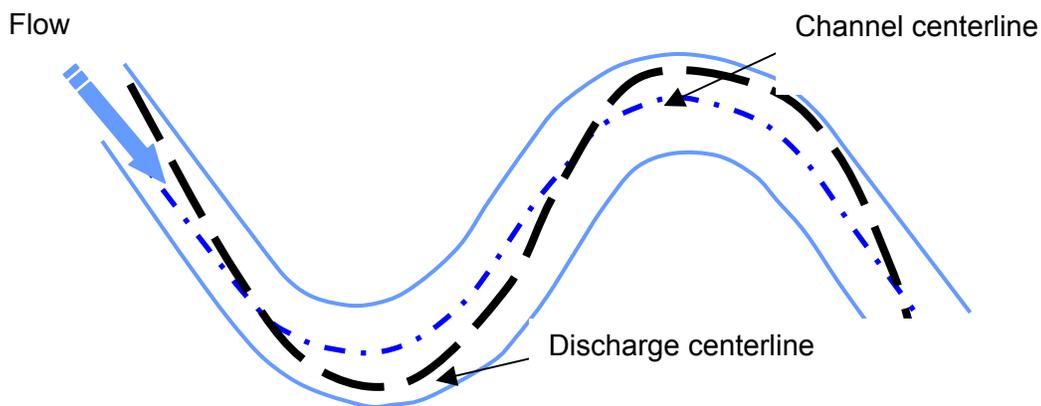
Figure 2: Channel centerline vs. discharge centerline.

To describe the basic process of meander formation, the distinction between the meander flow or discharge centerline and the channel centerline is important. As illustrated in Figure 2, the channel centerline (effect) lags the discharge flowline (cause). The flow in a stream does not progress in straight lines parallel to the stream channel. Rather the flow is comprised of a primary flow oriented downstream and transverse flows oriented perpendicular to the primary flow. Along the discharge flow path, these inward and outward transverse flows are balanced. However, along the channel flow path, there is considerable asymmetry. Because of the variable turbulence and secondary flow patterns, the flow velocity, sediment transport and boundary shear stress are non-uniform across the channel. These areas of turbulence produce alternating pulses of sediment, scour and deposition.

Areas of scour and deposition alternate along the axis of discharge flow producing a pool along the outer bend and a corresponding point bar on the inner bend. As the pattern of scour and deposition alternates from one side of the channel to the other, the thalweg (deepest portion of the channel cross section) and maximum flow velocity cross over the center of the channel. These cross over points become the riffles. The alternating pattern of bar building and bank scour causes straight streams to evolve into meandering ones with a sinuous pattern. Specifically, this is how channelized reaches eventually reacquire a sinuous shape.

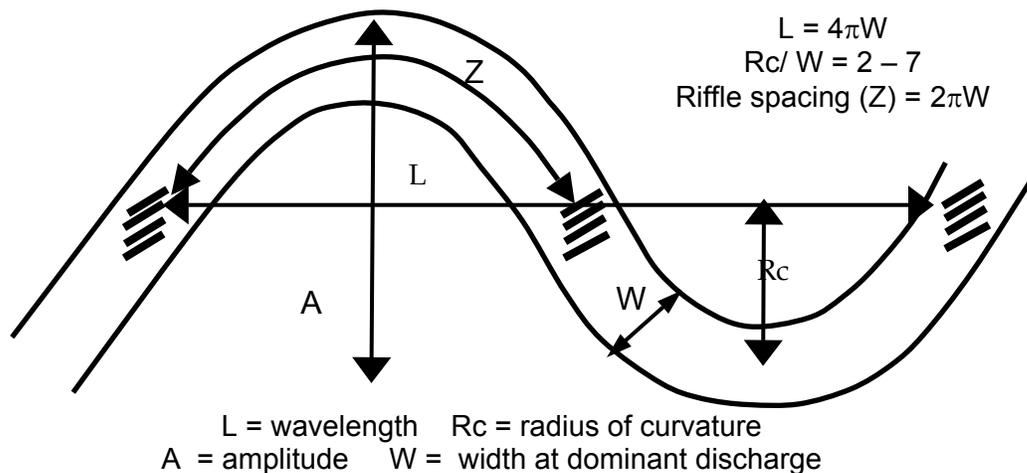
Figure 3: Meander geometry.

In alluvial streams of homogeneous material, meanders take the form of sine-generated curves. Leopold and Langbein (1969) demonstrated that this shape is the most hydraulically efficient form for turning water. Further, Chang (1998) presents a more analytical assessment of this meander plan geometry. These relationships between stream width, riffle spacing, meander wavelength and radius of curvature are remarkably consistent for streams and rivers throughout the world.

Most stable relationships in channel geometry include the channel width at the elevation corresponding to the dominant discharge. Riffle spacing ( $Z$ ) generally occurs every 6.3 bank widths ( $W$ ), where  $W$  is the width at the dominant discharge. This spacing is essentially  $2\pi W$ . Meander wavelength is approximately 12 bank widths, which approaches  $4\pi W$ .

The radius of curvature is also related to the channel width at dominant discharge elevation. The ratio of meander radius of curvature ( $R_c$ ) to channel width ( $W$ ) generally ranges between 2 and 7. Bagnold's (from Thorne et al, 1997) investigation of energy losses at bends confirmed the empirical observations by determining that flow energy losses are minimized through this shape. A tighter radius causes a flow separation and severe energy losses, a hydraulic inefficiency that is not persistent. In natural rivers, channel bends erode to a  $R_c/W$  ratio of 2-5 and then maintain that form, which indicates that the hydraulic efficiency is optimized by this form.

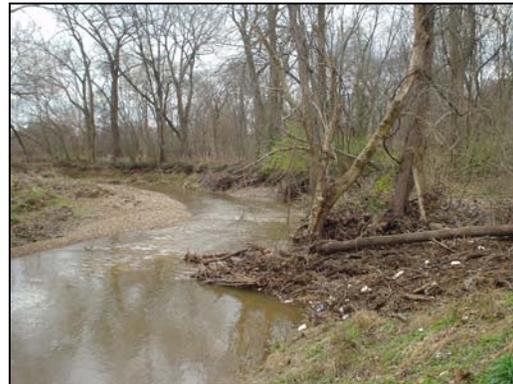
Evidence of meander adjustment includes the aggradation of bed material accompanied by the downstream progression of severe bank scouring opposite wide, steep-sided point bars. Erosion and mass wasting along meandering reaches occurs preferentially on the outside of meanders and extends downstream from the apex of the meander. Point bars are typically semi-consolidated, with steep downstream angles, and a bar width that exceeds the existing low flow channel width.

Indicators of meander adjustment –

- Aggradation of gravel and cobble bed material
- Preferential scour occurring on the outside of meanders
- Steep-sided point bars
- Bar width exceeding low flow channel width

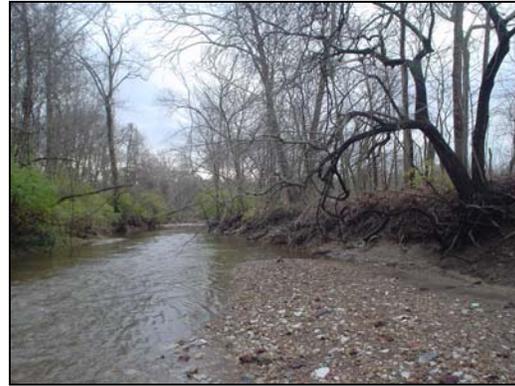
The study reach of Deer Creek begins at the northern property line of the Litzinger Ecology Center. The channel bed width ranges from 30 to 40 feet and 50 to 100 feet wide from the top of either bank. Bed material is comprised of consolidated gravel and cobble bed material, with an average particle size of approximately 8 to 12 inches for D90 and 2 to 4 inches for D60.

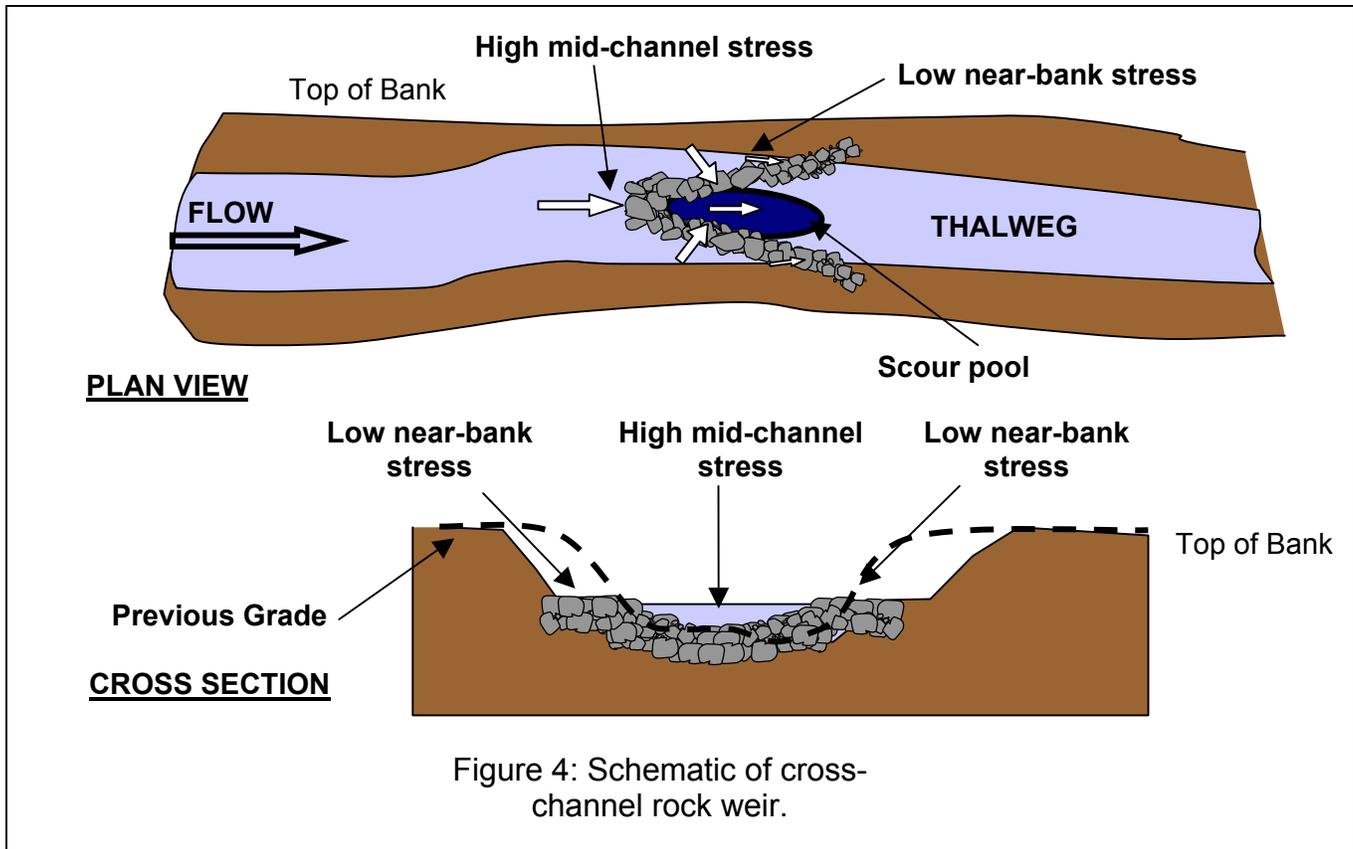
Figure 4: Schematic of cross-channel rock weir.

points is energy management using hydraulic roughness. Rough points created by designed structures or vegetation direct flow away from vulnerable areas. Strategic use of hydraulic roughness also dissipates energy and lowers the stress on bed and banks in general.

meander or protecting bridge piers is part of the design intent. Figure 4 illustrates the shear stress distribution across a common type of rock weir.

We recommend completing a detailed design analysis, including a hydrologic/hydraulic analysis to confirm the diagnosis presented in this report. This would allow the design and strategic placement of structures such as cross-channel rock weirs to center the thalweg and reduce near-bank shear stress. In addition, vegetated rock toe armor and stream barbs along the outside of meanders would protect eroding banks from continued toe scour, and direct the thalweg away from critical infrastructure and threatened property, such as the entrance road and Ecology Center buildings.
