Deer Creek Bank Erosion Monitoring Past, Present, and Future

Litzsinger Road Ecology Center
Missouri Botanical Garden

A project for completion of degree
MS Environmental Studies
Antioch University New England
Maisie Tyler Rinne
2013

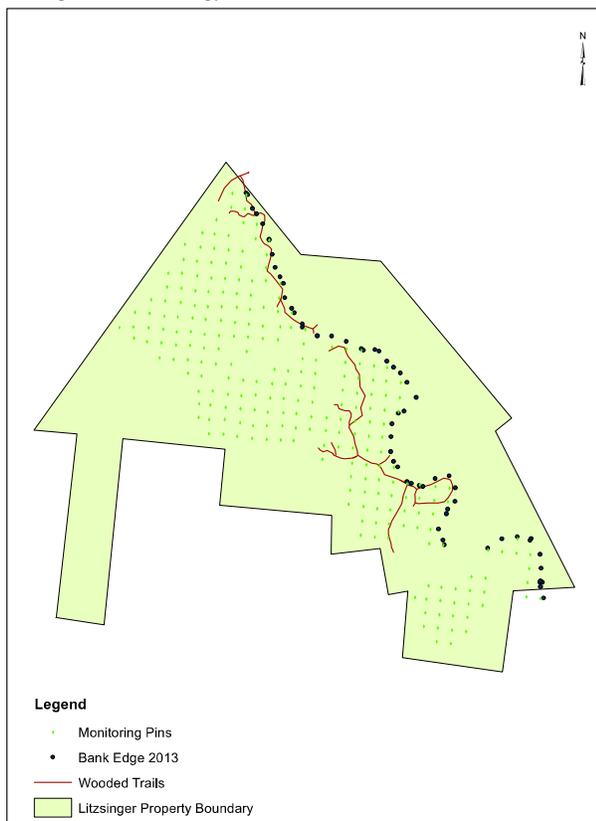
Litzsinger Road Ecology Center Deer Creek Bank Erosion Study

It is the hope of this study that, with the addition of future data, these maps will be used for educational purposes, illustrating the changing bank edge over time. Though various bank points had been measured in the past (1995, 1996, 2009), methods used to collect this information was unrecorded and therefore not useful in comparing with current measurements. Therefore, this is the first full set of recorded data. In the future, all 39 points should be monitored every 3 years with crucial points monitored annually. Another recommended project for the future is to improve the visuals of the above maps.

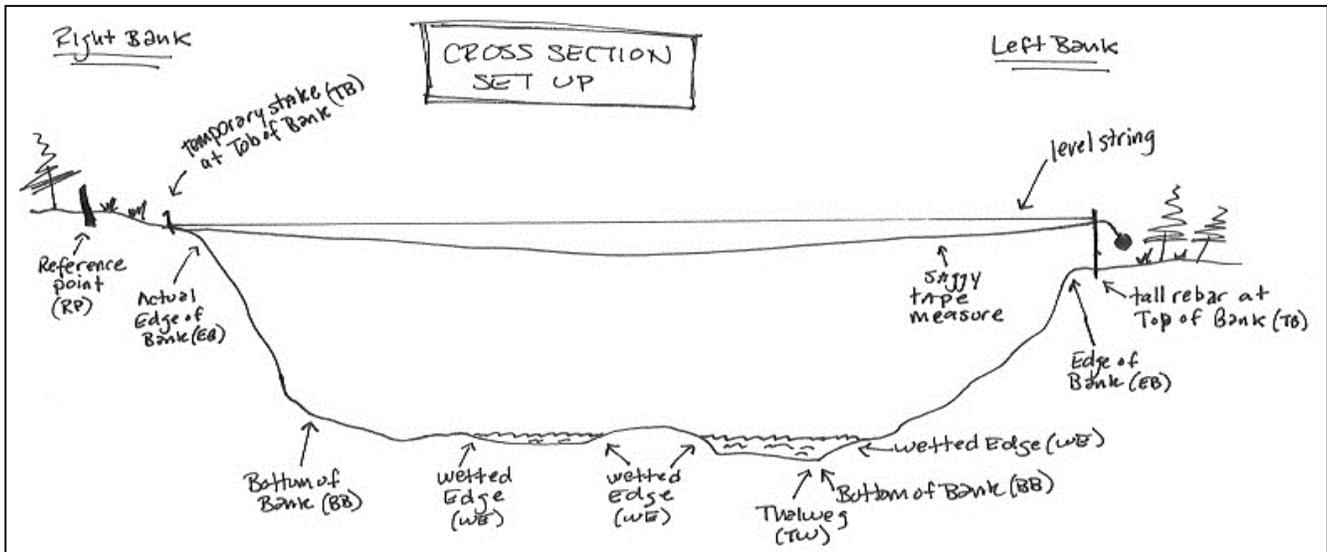
Figure 2

5. Using a level, ensure that the string is level across the channel and that one of the ends of the string is touching the ground. Secure the tape measure under the string as taught as possible, though it will sag a bit regardless (see figure 2).
